Device **TC26x**
Marking/Step **ES-BC, BC**
Package **see Data Sheet**

No. 165/17

This Errata Sheet describes the deviations from the current user documentation.

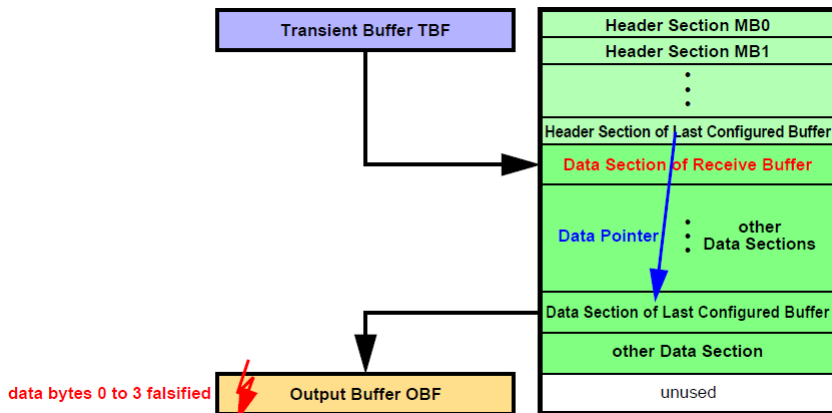
Figure 1 Message buffer transfer from Message RAM to OBF

- a) Message buffer transfer from Message RAM to OBF

When the message buffer has its payload configured to maximum length (PLC = 127), the OBF word on address 00h (payload data bytes 0 to 3) is overwritten with unexpected data at the end of the transfer.

2) Ensure that the Data Section directly following the Header Partition is assigned to a transmit buffer.

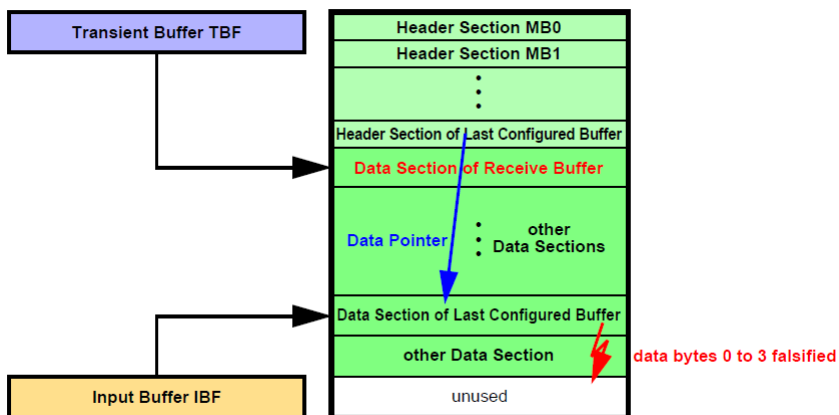
Figure 2 Message buffer transfer from IBF to Message RAM

b) Message buffer transfer from IBF to Message RAM

After the Data Section of the selected message buffer in the Message RAM has been written, one additional write access overwrites the following word in the Message RAM which might be the first word of the next Data Section.

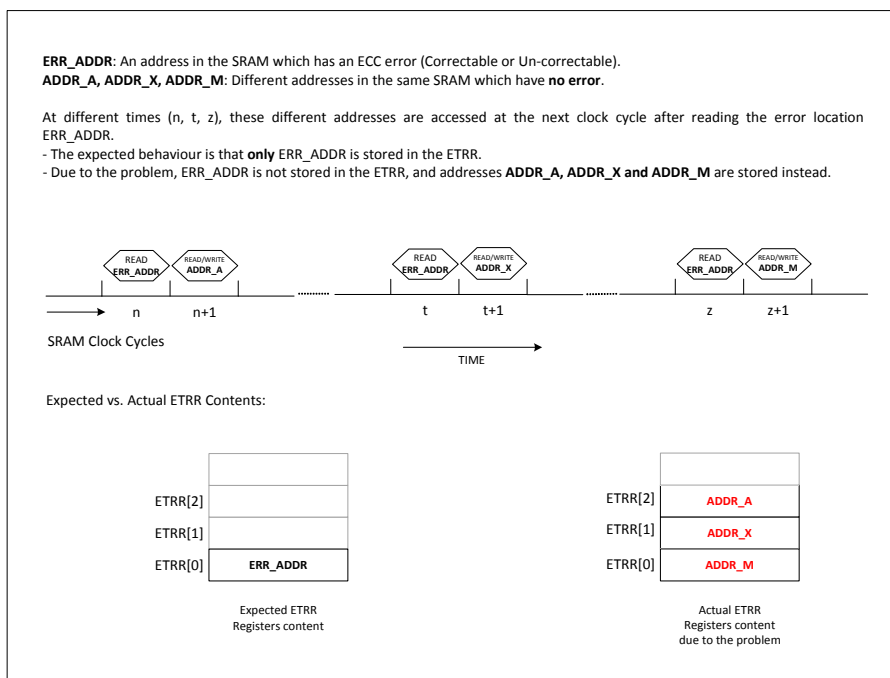
Figure 4 Example sequence showing how registers ETRRx may be filled with “Error Free” addresses

When such a consecutive access sequence (read from ERR_ADDR followed by read/write of different address(es)) happens multiple times, registers ETRRx are filled with addresses that have actually no error – and the SRAM address which actually has an error is not stored indeed. **Figure 4** shows such an example scenario.

The consequence of the scenario explained in **Figure 4** is that a single error in the SRAM – example just one correctable error at a location ERR_ADDR – can

If there is at least one valid ETRR entry (i.e. $MCx.ECCD.VAL \neq 0$) then the software shall run a Non-Destructive-Inversion (NDI) Test on the affected SRAM. Please refer to application note AP32197 (AURIX™ Memory tests using the MTU) for an example regarding running this test.

At the end of this test, if an ETRR overflow is detected ($MCx.ECCD.EOV = 1_B$) then the MCU shall be considered non-operational. Refer to section on Correctable SRAM Error handling in the Safety Manual.

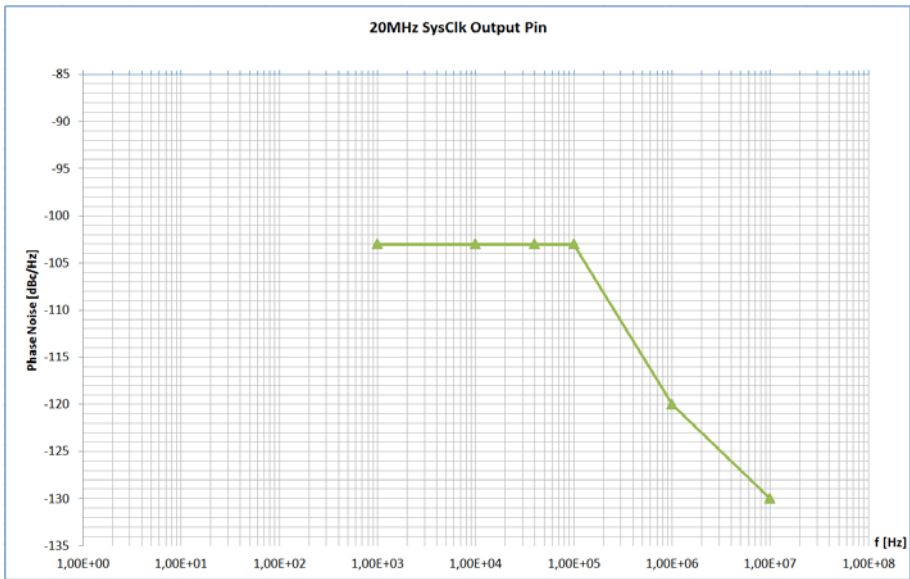
Figure 8 Phase Noise Density on SysClk Output Pin

Consistently, measurements on the HSSL/HSCT communication channel using the SysClk signal with I_{PN} from above show that the ultimate target of $BER_{20} = 10^{-12}$ is met. In such a measurement setup, both the master and the slave are microcontrollers of the AURIX™ family.

The diagram below shows the phase noise density on the SysClk pin when no application pattern but only the HSSL/HSCT subsystem is running:

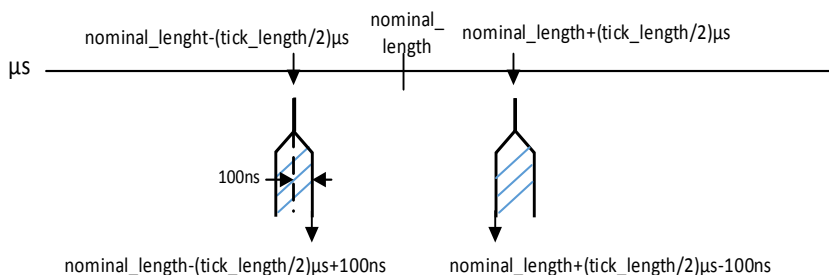
Figure 14 SENT Standard Tolerance

The length of a nibble in the SENT protocol determines the value of this nibble. For each value this length can vary, but it has to be at least inside a given range. This range is given by the SENT standard.

- The lower border is $\text{nominal_value} - (\text{tick_length}/2) \mu\text{s} + 100 \text{ ns}$
- The upper border is $\text{nominal_value} + (\text{tick_length}/2) \mu\text{s} - 100 \text{ ns}$.

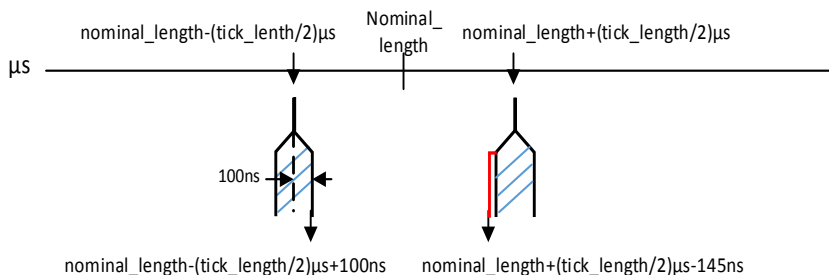
Figure 15 SENT Tolerance of this Design Step

In this design step the range is delimited as follows:

- The lower border is $\text{nominal_value} - (\text{tick_length}/2) \mu\text{s} + 100 \text{ ns}$
- The upper border is $\text{nominal_value} + (\text{tick_length}/2) \mu\text{s} - 145 \text{ ns}$.

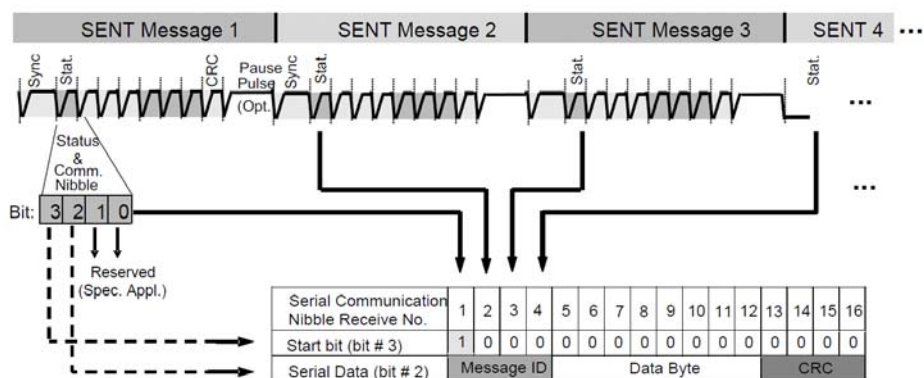
Figure 16 Short Serial Message, Serial Data Encoding over 16 messages

Figure 16 shows a corrected version of this figure.
